# Fixation of Acromion Fracture by Distal Radius Plate: A Case Report

## Abstract

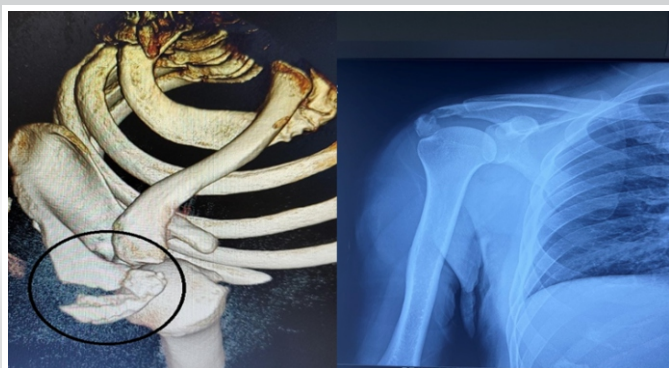
Figure 1: Pre-operative X-ray and 3D CT images

The patient is a 54 years old male who presented to our hospital's OPD after being referred from some other hospital with history of slip and fall at home. On further examination the patient had severe pain, ecchymosis, abrasions and swelling over the affected shoulder. An initial X-ray of the shoulder joint was done which revealed displaced fracture of the acromion process and was further classified as Kuhn Type II acromion fracture. (Fig. 1)

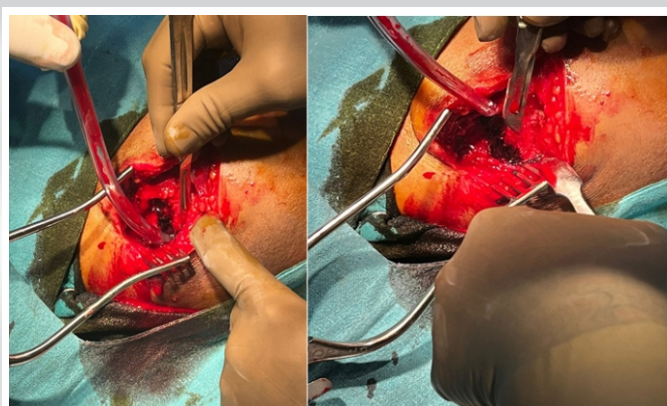
Figure 2: Intraoperative images showing dissection and fracture morphology

The subcutaneous tissue was incised and cleared thus exposing the underlying muscle fibers. One might have to release partially the deltoid anteriorly and the trapezius posteriorly in order to expose the full extent of the fracture. The neurovascular structure specially the course of axillary nerve should be kept in mid during dissection when extended inferiorly and implant placement. (Fig. 2)

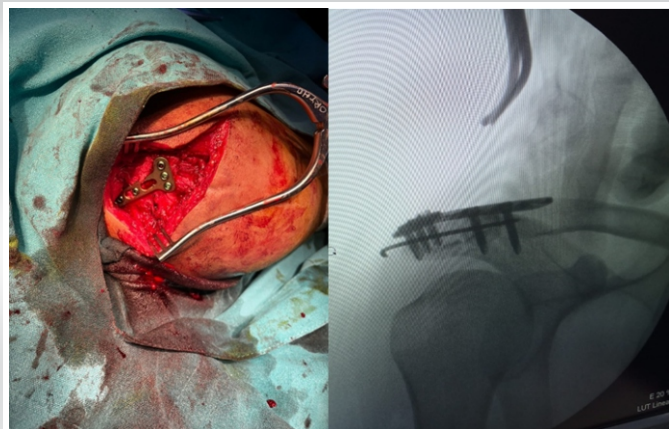
Figure 3: Final intra operative pictures showing final implant position

After clearing the fracture ends of the hematoma and intervening soft tissue the fracture was reduced and held provisionally with the help of K wires. As the scapula is mostly a cancellous bone with less cortical component the implant fixation is a bit hard. Most of the times either acromion was held with the help of Wires as a tension band wiring construct or the help of cancellous screws. Some of the authors have even used a recon plate for the fixation of such fractures. Our case has been fixed with the help of a 2.7 mm distal radius plate, cortical and mostly locking screws. An additional K wire was left in situ passing through the acromion to provide extra strength and stability to the construct. (Fig. 3)

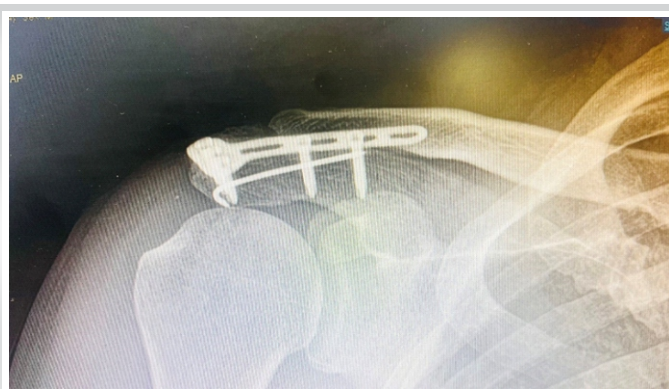
Figure 5: 3 months post-operative X-ray showing perfect union

Post-operative X-rays were also done at post op day 1 along with the same at 1, 3 and 6 months respectively. The signs of union were seen at 3 months along with union fully achieved radiologically at the end of 6 months. There were also no signs of implant loosening, K wire back

out. Even the impingement of hardware was not experienced by the patient even after 6 months of surgery. (Fig. 5) (Fig. 6)

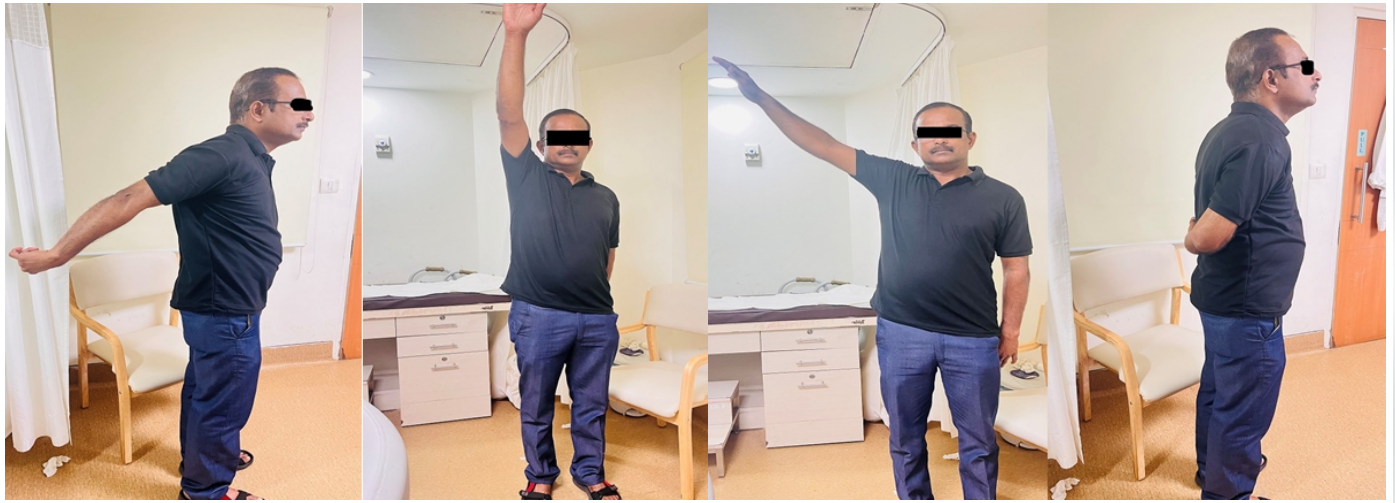
Figure 6: ROM of the operated shoulder at the end of 6 months
